PROPERTY CONDITION REPORT

Report #: S031404-12RT

Introduction Notes	8
SITE AND GROUNDS	12
STRUCTURE & EXTERIOR	14
GARAGE / PARKING STRUCTURE	17
ATTIC / ROOF STRUCTURE	19
ROOF	21
PLUMBING SYSTEMS	24
WATER HEATER	26
ELECTRICAL	28
HVAC (HEATING, VENTILATION AND AIR CONDITIONING)	32
LAUNDRY AREA	35
KITCHEN & APPLIANCES	37
BATH AREAS	39
INTERIOR ROOMS & OTHER PROVISIONS	41
SUGGESTED SAFETY IMPROVEMENTS	43

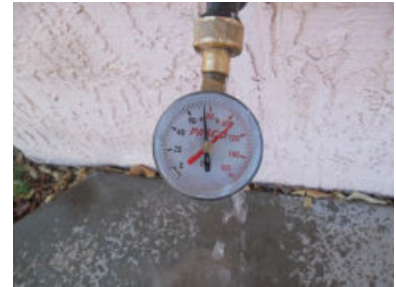
The water supply for the building, measured at an outside hose bibb was 70-75.

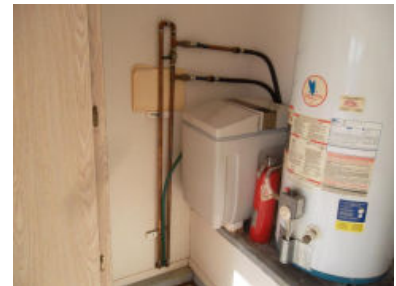
Note: The house has been equipped with a water softener. Water softeners and/or any whole house filtering system is not within the scope of a home inspection and therefore not inspected. It is recommended that the manufacturer is contacted for information concerning the unit and testing to ensure the unit is working properly.

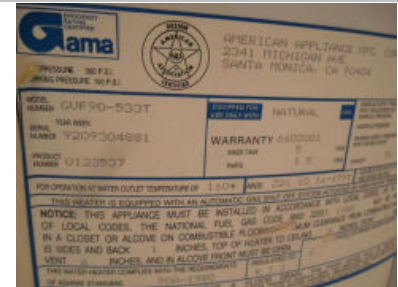
The location of the water heater was in the garage. The energy source for the water heater was natural gas and the storage capacity of the tank was 50 gallons. The name of the manufacturer or the name brand name of this unit was A.O. Smith. The age of the water heater can usually be found in the serial number, which indicates that the date of manufacture was 1992.

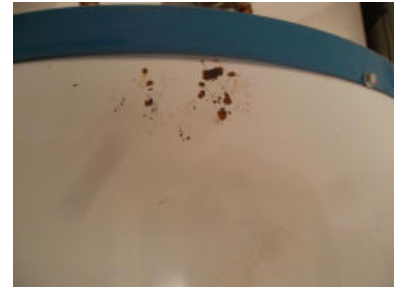
Monitor: There is some corrosion along the top of the water heater.

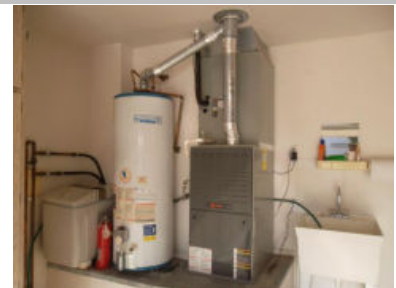
The water heater is located in the garage and is adequately protected from vehicle impact. Protection is provided by either a floor elevation change with a curb 4" high and 3' deep or located out of the travel path or a minimum 3" steel pipe bollard installed a minimum of 18" below and a minimum of 44" above the finished floor in front of the water heater.

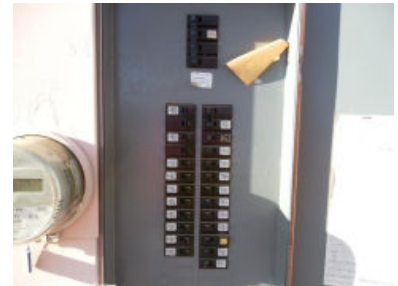
The service voltage available to this building was single phase 120/240 volts. Branch circuit overload protection was provided by circuit breakers and the available ampacity provided through the service was 200 amps.

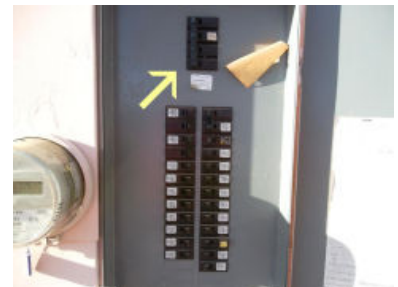
The main disconnect for the electrical system is a single throw main breaker that is located at the top of the panel.

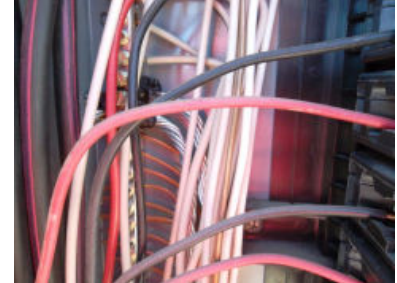
The branch circuit conductors (wires) were a combination of copper and aluminum. The aluminum conductor was stranded, which is commonly used on 220-240 volt circuits (range, dryer, HVAC).

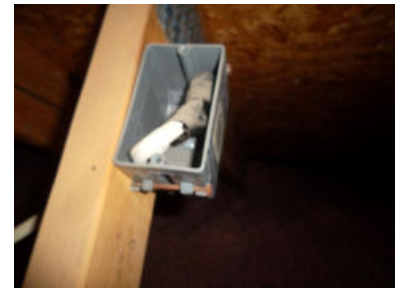
Safety Concern: An open junction box was observed inside the attic. A cover should be installed for safety.

Safety Concern: An open junction box was observed inside the attic. A cover should be installed for safety.

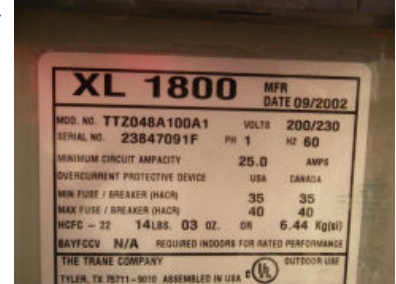
The name of the manufacturer or brand name for the package unit(s) or condensing unit(s) was Trane. The age of the unit(s) can usually be found in the serial number or on the label or was looked up based on the information available, which indicates that the date of manufacture was 2002.

The serial number is 23847091F and the model number is TTZ048A100A1. This unit is most likely a 12 SEER (Seasonal Energy Efficiency Ratio). Parts for units less than 13 SEER may only be available for eight (8) additional years due to higher standards. Call your local HVAC contractor for additional information.
